# Correlation between acoustic emission distribution and stress variation through the depth of RC beam cross sections

LIU Simeng<sup>1,2</sup>, Matthew R. Pearson<sup>3</sup>, Mark Eaton<sup>3</sup>, Rhys Pullin<sup>3</sup>

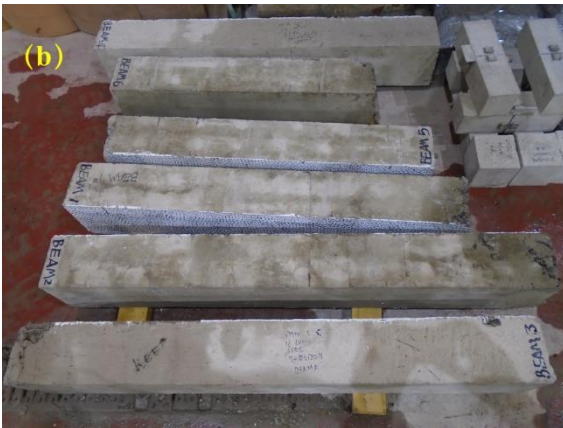
**Figure 3.** (a) The design details of the simply supported RC beams tested in the study (Units in mm), (b) a photo of all specimens.

The details of these specimens are shown in Figure 3 and Table 1. The sections of all beams are rectangular, 120mm wide and 150mm or 155mm deep, with a clear span of 620 mm (Table 1). In every specimen, one steel bar (N1), 12 mm in diameter, is provided as tensile reinforcement, and another bar (N2), 6 mm in diameter, is used as compressive reinforcement. Stirrups (N3), 6 mm in diameter, are placed at 50 mm c/c distance to avoid shear failure. The beams were designed in accordance with British Standard for grade C40, and the mixture proportion of the concrete was that cement : fine aggregate : coarse aggregate : water = 1:2:3:0.5, by weight. Steel fibres, 30mm or 60mm long, were mixed in the concrete, with a ratio of 1% or 2% (by weight), to obtain the Steel Fibre Concrete (SFC). The specimens were cast in a specially made wooden mould and a standard steel mould, and compacted using a needle vibrator.

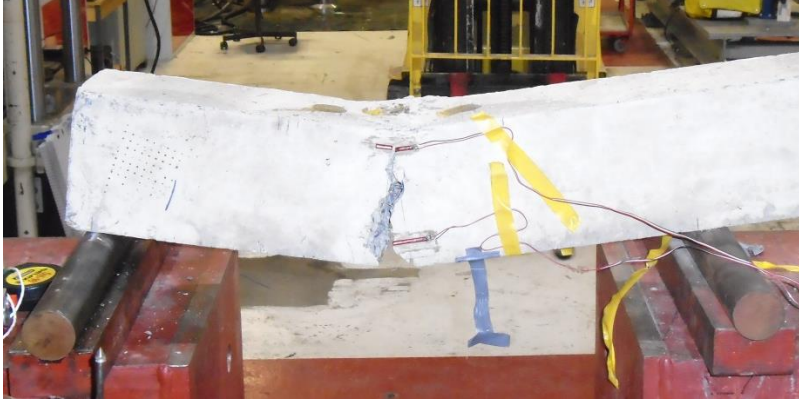
**Figure 6** The load-deflection curve (Upper) and the failure shape (Lower) of Beam 1.

The failure of Beam 1, i.e. a three-stage loading process, is detailed as follows. In the first stage, no cracks were observed, and the stiffness of the beam was of the greatest magnitude. Theoretically, all parts of each cross section are effective in resisting external moment, and concrete stress is proportional to strain. The stage corresponds to *I-Ia* in the first panel of Figure 6. In the second stage, cracks appeared in the tensile zone very close to the notch, and the deflection of the beam increased significantly, meaning its stiffness also appreciably declined. In theory, the stress increases with strain nonlinearly, and to a cracked section, only a part of the section provides resistance to the bending moment. The second stage corresponds to *II-IIa* in Figure 6. In the third stage, many cracks appeared in both the tensile and compressive regions; and strain increased rapidly until the bearing capacity of the beam was reached; simultaneously, tensile

reinforcement yielded. More importantly, the stiffness dramatically reduced. Finally, a part of the concrete in the compressive region was crushed, and then the beam completely failed (See the lower panel of the figure). The last stage corresponds to *III-IIIa* in Figure 6.

The above description regarding the failure of Beam 1 is in line with established research [34, 37-39]. Testing of RC beam structures can be divided into several important stages, and these stages can be identified on a load vs. deflection curve, such as the upper panel of Figure 6. Accordingly, all critical stages studied in subsequent parts are listed in Table 3. More importantly, their significance in structural respects is also introduced briefly. Additionally, several critical states listed in Table 3 and Figure 6 are also investigated later.
